BILATERAL FEMORAL COMPONENT BREAKAGE IN TOTAL HIP REPLACEMENT: A CASE REPORT

Paraic Murray, MSc, MCh; Cecil H. Rorabeck, MD

Breakage of the femoral component of modern total hip prostheses is rare. We report the case of a 65-year-old man who underwent staged bilateral cemented total hip replacement with titanium prostheses (Biomet; Warsaw, Ind.). Three years later the prosthesis on the right failed and was revised. Then, 2 years after that, the contralateral prosthesis also failed.

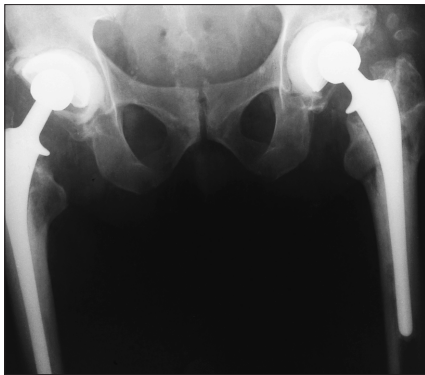
Follow-up x-ray films revealed progressive loosening of the acetabular components bilaterally (Fig. 3), but he remained asymptomatic and continued to participate in physical activities, which included golf.

FIG. 3. Progressive loosening of the acetabular components after hip replacement.

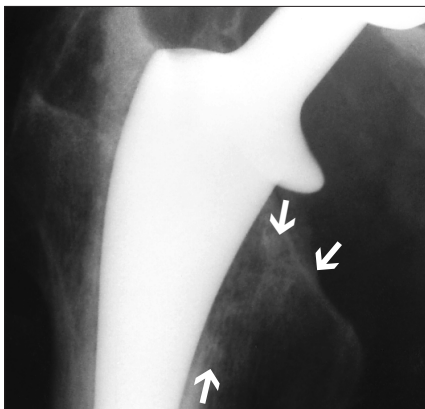
Close inspection of the radiographs demonstrated a lucent line developing between the prosthesis and the cement bilaterally in Gruen⁴ zones 1 and 7 (Fig. 4). Eventually the prosthesis fractured in its mid-portion, at the lower end of this lucency (Fig. 5). The

FIG. 4. The development of a lucent line in Gruen zones 1 and 7 (arrows).

In our case the implant used was titanium. From an early stage a radiolucent line was seen between the prosthesis and the cement in zones 1 and 7. This gap on supine x-ray films may have been due to bending of the prosthesis, flow in the cement or tapping of wear debris pumped into the gap during cyclical loading (Fig. 8). Cyclical bending of the prosthesis obviously occurred, as evidenced by the burnishing of the prosthesis on either side of the ultimate prosthetic fracture. Cyclical bending of a distally fixed prosthesis, resulted in fatigue failure as the degree of deflection was above the fatigue threshold. Given

The advantage of titanium in joint replacement lies in its ability to osseointegrate. Titanium is no longer recommended for the bearing surface in joint replacements, and its role in cemented joint replacement may also be in question. Although a cemented titanium femoral stem is no longer recommended, it is important to point out the importance of maintaining an adequate cement mantle in Gruen zones 1 and 7 as failure to do so may result in micromotion and subsequent stem fracture irrespective of the metal used.

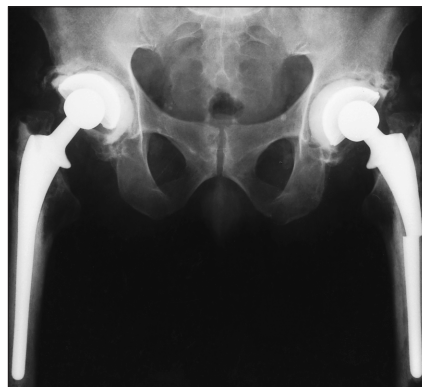
FIG. 5. The fractured stem of the left prosthesis.

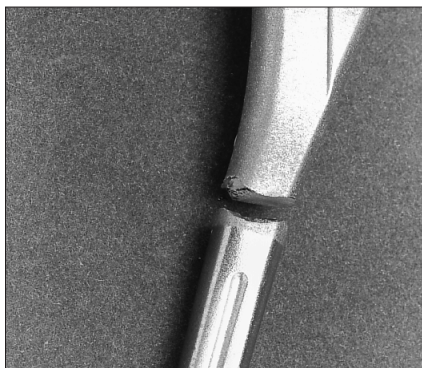
prosthesis on the left failed in 1994 and that on the right in 1996. Inspection of the latter prosthesis showed that this breakage occurred close to but not directly at the junction of the surface texture change (Fig. 6). The original prosthetic fracture was in a similar position. Burnishing was evident both proximal and distal to the stem fracture (Fig. 7). The burnishing was evident mainly on the medial and posterior surfaces. The extent of the burnishing provided direct evidence of movement of the prosthesis in the cement mantle along much of the stem length. At the time of revision the distal portion of the prosthesis was well fixed in the cement mantle.

FIG. 6. The fractured prosthetic stem.

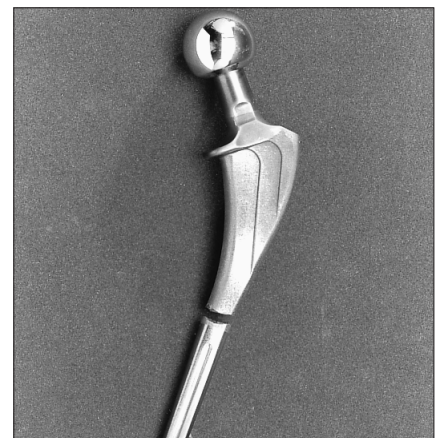
FIG. 7. The fractured prosthetic stem with apparent burnishing.

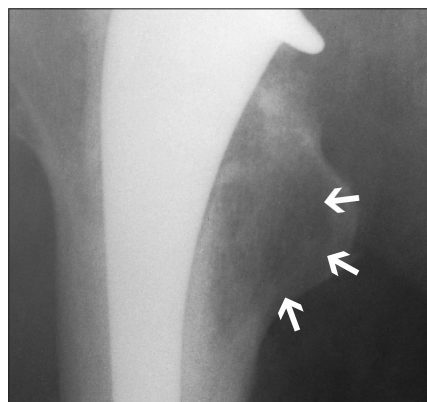
FIG. 8. Radiograph showing wear debris.
