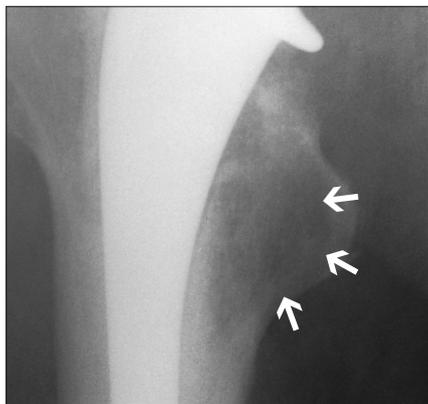
In our case the implant used was titanium. From an early stage a radiolucent line was seen between the prosthesis and the cement in zones 1 and 7. This gap on supine x-ray films may have been due to bending of the prosthesis, flow in the cement or tapping of wear debris pumped into the gap during cyclical loading (Fig. 8). Cyclical bending of the prosthesis obviously occurred, as evidenced by the burnishing of the prosthesis on either side of the ultimate prosthetic fracture. Cyclical bending of a distally fixed prosthesis, resulted in fatigue failure as the degree of deflection was above the fatigue threshold. Given

FIG. 8. Radiograph showing wear debris.

that the prosthesis in question was a relatively small cross-section, along with the lower Young's modulus of titanium, the degree of bending expected would be greater than that of a bulkier prosthesis made from a stainless steel alloy.

The advantage of titanium in joint replacement lies in its ability to osseointegrate. Titanium is no longer recommended for the bearing surface in joint replacements, and its role in cemented joint replacement may also be in question. Although a cemented titanium femoral stem is no longer recommended, it is important to point out the importance of maintaining an adequate cement mantle in Gruen zones 1 and 7 as failure to do so may result in micromotion and subsequent stem fracture irrespective of the metal used.
