BILATERAL FEMORAL COMPONENT BREAKAGE IN TOTAL HIP REPLACEMENT: A CASE REPORT

Paraic Murray, MSc, MCh; Cecil H. Rorabeck, MD

Breakage of the femoral component of modern total hip prostheses is rare. We report the case of a 65-year-old man who underwent staged bilateral cemented total hip replacement with titanium prostheses (Biomet; Warsaw, Ind.). Three years later the prosthesis on the right failed and was revised. Then, 2 years after that, the contralateral prosthesis also failed.

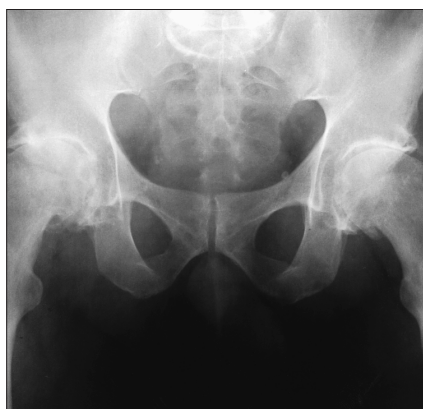
FIG. 1. Radiograph of the hips of the 65-year-old man before hip replacement.

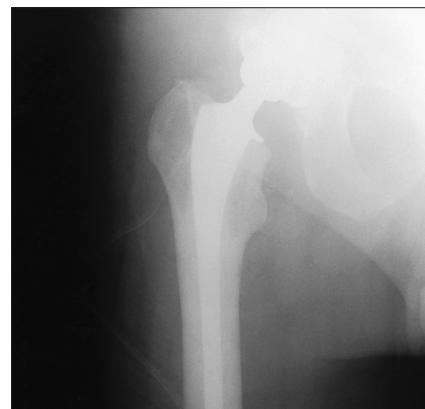
FIG. 2. Postoperative radiograph of a right total hip joint replacement.

mented total hip replacements as part of an ongoing study comparing cemented and cementless total hip replacement. Prosthesis size was chosen to provide a cement mantle³ of at least 2 mm over the entire prosthesis after standard preparation of the proximal femur (Fig. 2).
